Infrared thermography: part of an effective preventive maintenance strategy at Weyerhaeuser

Application Note

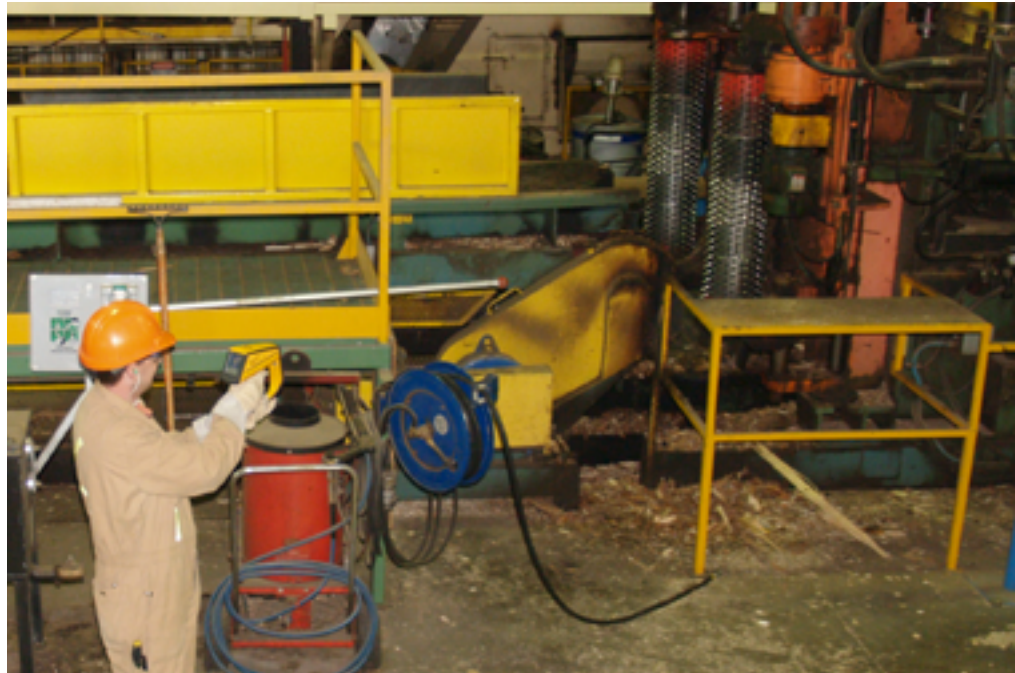
Preventive maintenance applications for the Fluke Ti30 Thermal Imager are plentiful in an industrial environment such as this Weyerhaeuser location in Drayton Valley, Alberta.

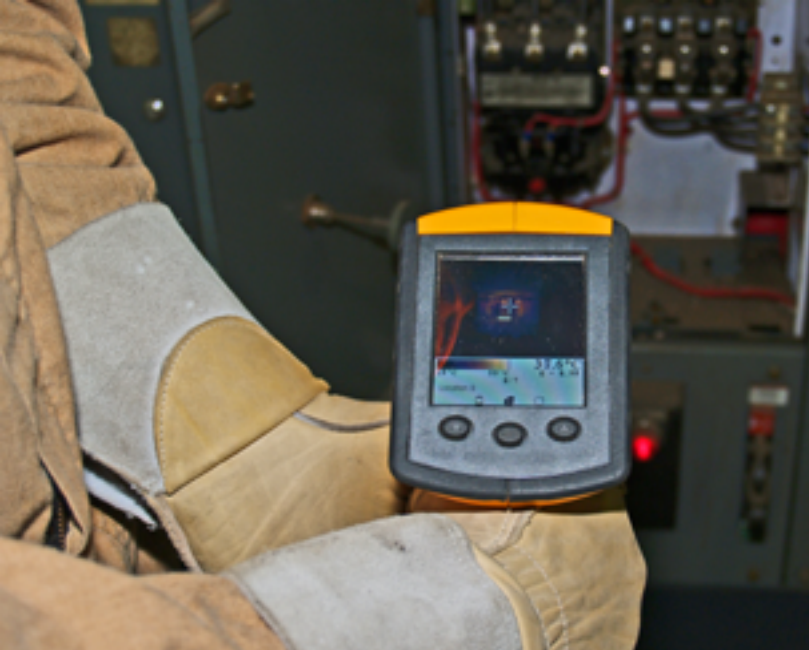
In addition to spotting problems, thermal imagers are useful for validating that repairs have been effective.
